FX2-Division: Shared Bicycle and Pedestrian Platform Evaluation

TRANSPORTATION RESEARCH AND EDUCATION CENTER

Final Report

August 2024

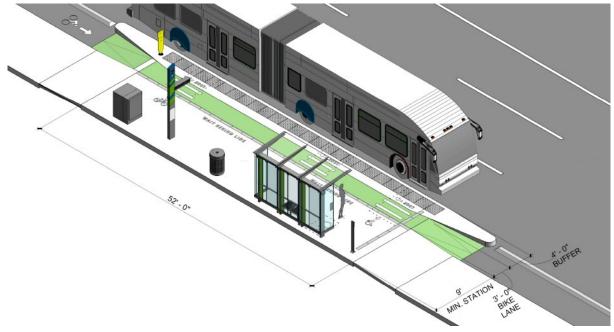
The design seeks to mitigate bicyclists moving out into traffic on the SE Division Street corridor; however, it also depends upon users understanding how to navigate the shared space, included where to wait for the bus, how to board and alight, and when and where bicyclists should yield to allows riders to access the buses. Figure 1 shows the standard FX2 platform design. The standard design includes a 4 feet boarding/alighting zone with a white truncated dome. There is a 3' green bike lane with crosswalk markings which are aligned with the FX2 door openings. There is a 6" strip of tactile walking surface indicators (TWSI) to mark the border of the bike lane and waiting area. Also included in the design is a transit rider waiting area with amenities and a shelter. When no bus is at the platform, transit riders are intended to wait behind a marked line of tactile guide strips, and bicyclists are free to pass through the platform area. When a bus arrives, bicyclists are intended to stop at a stop bar prior to passing through the platform area, and bus riders are to board and alight.

Figure 1 TriMet schematic of standard FX2 platform design (Source: TriMet)

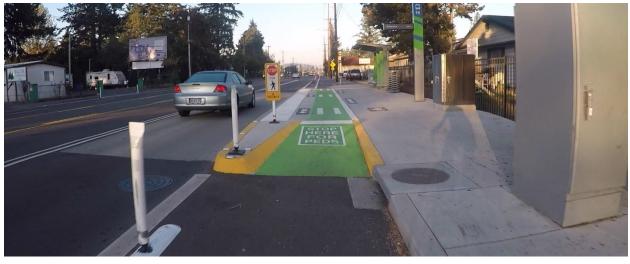
Figure 2 Bicyclist perspective of standard FX2 platform

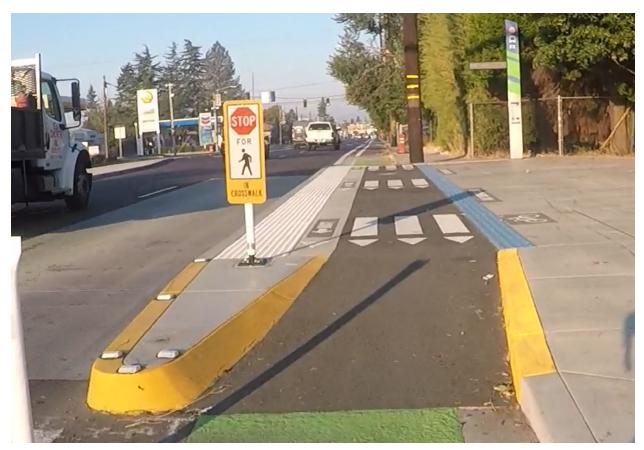
Variations to the standard design were implemented at FX2 platforms located on ODOT property adjacent to I-205 and the MAX Green Line due to site constraints and variations in ODOT and PBOT guidelines and requirements. Figure 3 shows the transit stop at SE 93rd Ave. The following differences were observed compared to the standard design. At these locations:

- The bicyclist stop bar and "Stop here for peds" markings were absent.
- There is a 4' wide black bike lane, rather than 3' wide green bike lane present with the standard design.
- There is a 12" blue strip of TWSIs, rather than 6" white strip and a larger / deeper waiting area.
- On the approach to the platform, there is a "Bike Lane Ends" sign, and on the far side of the platform there is a "Bike Lane" sign to imply the resumption of the bike lane. Note that these signs were added after the photo in Figure 3 was taken.

Figure 3 FX2 westbound platform at SE 93rd Avenue, incorporating design variations

- We observed few differences in bicyclist and passenger behavior between the standard FX2 shared platform design and the variations at SE 93rd Avenue.
- Survey respondents and ride-along participants liked the green color for the bike lane.
- Ride-along participants liked the wider blue TWSI strip separating the bike lane from the transit waiting area at the SE 93rd Avenue platform areas, noting it better conveyed a different purpose than the street adjacent white TWSI boarding area.
- Consistency in design across locations should be a priority going forward.

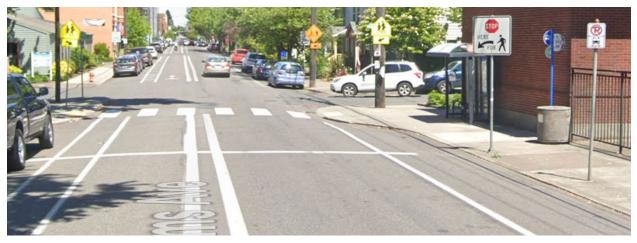
Complications may arise if bicyclists need to be routed from the right side of the street over to the left side of the street. An example of this approach is North Williams Street in Portland, OR (Figure 4).

Figure 4 Left-side bike lane with right side bus stop, North Williams Street in Portland, OR (Source: Google Street View)

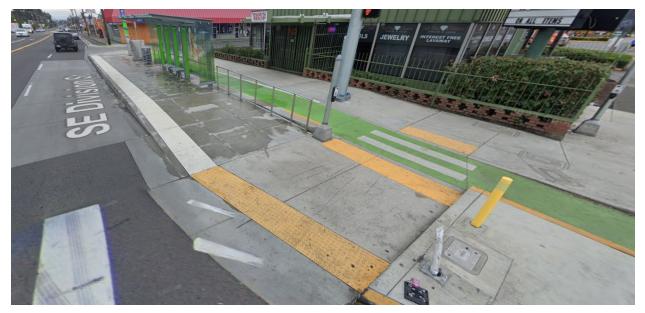
Figure 5 Floating transit island on SE Division and 122nd Avenue in Portland, OR (Source: Google Street View)

Examples of permanent floating bus transit islands include those on SE Division in Portland (Figure 5) and on Roosevelt Way NE in Seattle (Figure 6). Examples of modular floating bus islands include SE Hawthorne in Portland (Figure 7) 108th Ave NE in Bellevue, WA (Figure 8)

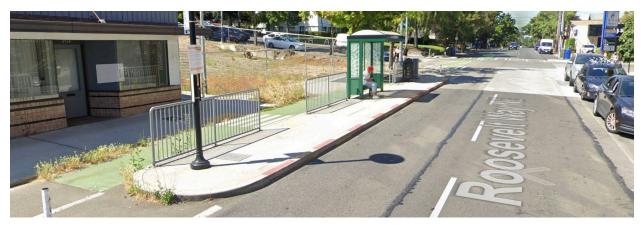
Figure 6 Floating transit island on Roosevelt Way NE in Seattle, WA (Source: Google Street View)

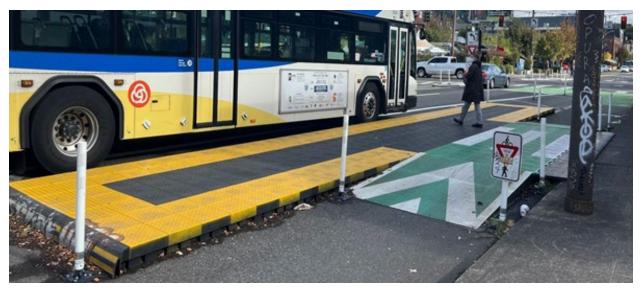
Figure 7 SE Hawthorne Blvd at 12th Avenue in Portland, OR (Photo: Kyuri Kim)

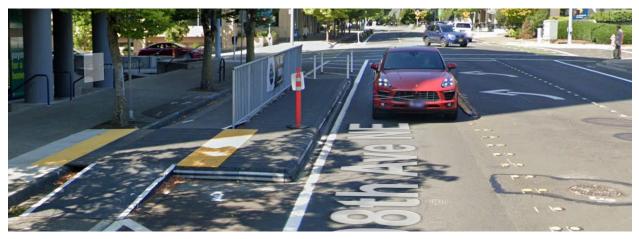
Figure 8 108th Avenue NE in Bellevue, WA (Source: Google Street View)

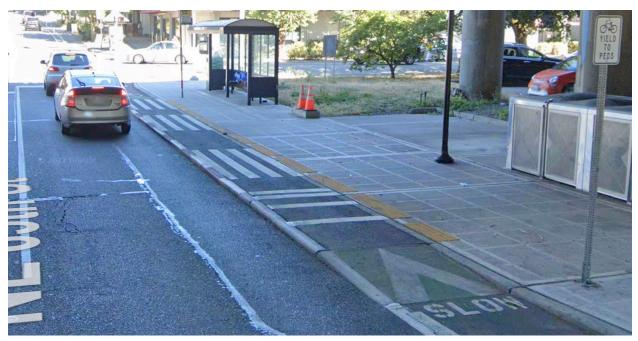
Figure 11 Cycle track bus stop with no additional boarding area. Seattle, NE 65th Avenue (Source: Google Street View)

Examples of this type of stop are included below, including a stop on NE 65th Street in Seattle (Figure 9), and a stop on Sherbourne Street in Toronto, Ontario (Figure 10). These two designs do not feature an additional boarding zone on street side of the bike lane. Another version of this design from West 4th Street in Charlotte, NC (Figure 11) contains a narrow, marked boarding area.

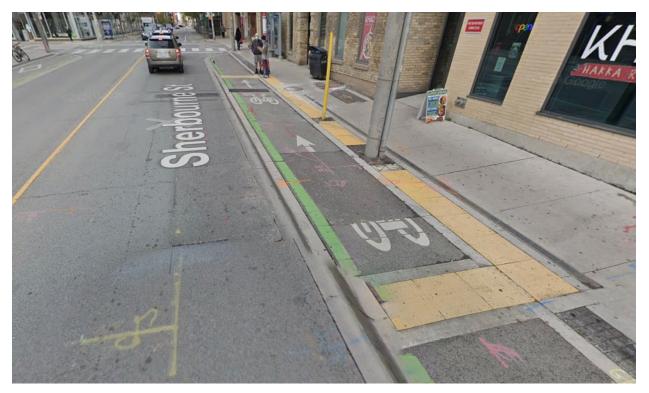
Figure 12 Cycle track bus stop with no additional boarding area. Toronto, ON, Sherbourne Street (Source: Google Street View)

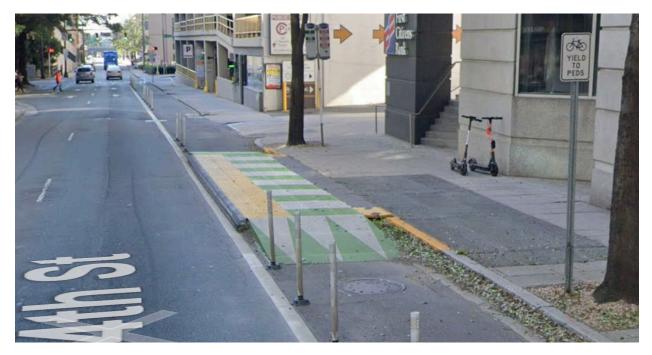
Figure 13 Shared transit stop with marked boarding area. Charlotte, NC, W. 4th Street (Source: Google Street View)
