District Department of Transportation Bicycle Facility Evaluation

Bicycle Facility Evaluation Washington, DC

Prepared for:
District Department of Transportation

Prepared by:
Kittelson & Associates, Inc.
Jamie Parks, AICP
Paul Ryus, PE
Alison Tanaka

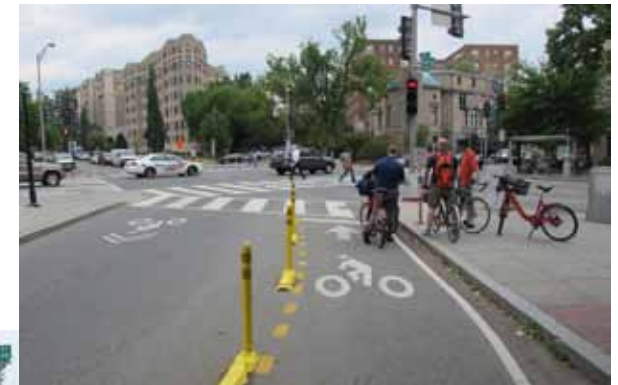
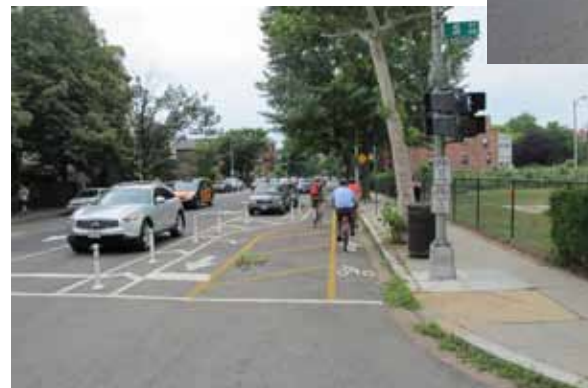
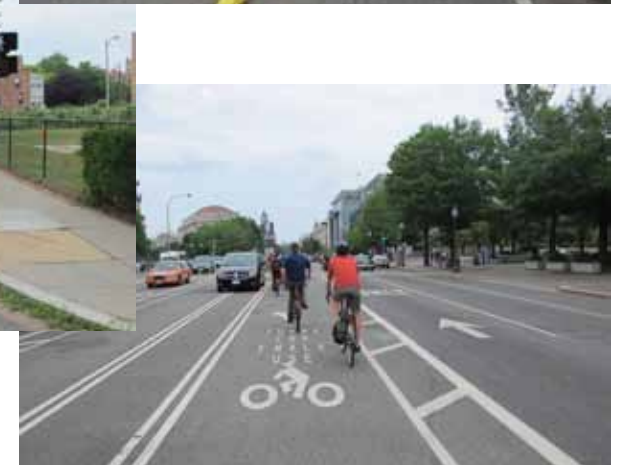
Clockwise from top: Bicycle facilities at the entrance onto U Street from New Hampshire Avenue; Pennsylvania Avenue at 4th Street; and 15th Street at S Street.

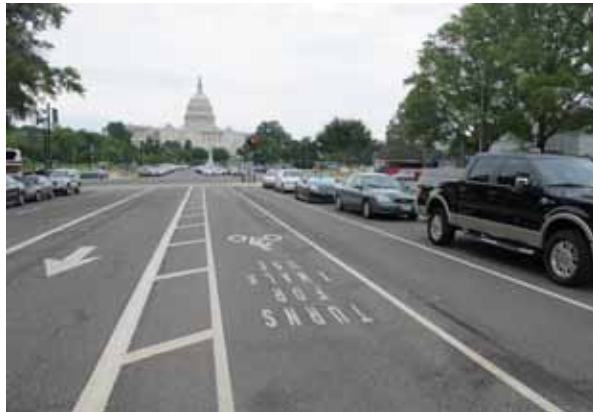
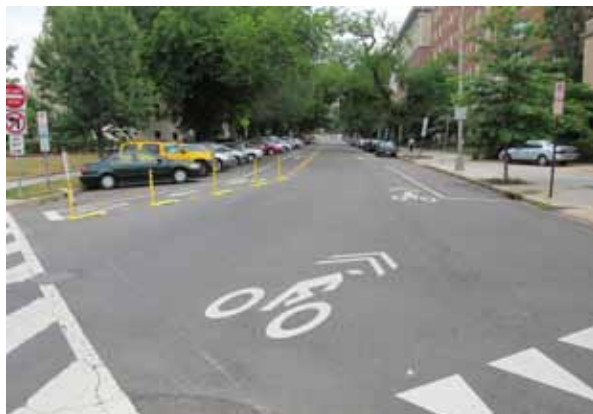
Top: Pennsylvania Avenue at 3rd Street. **Bottom:** Intersection of 16th Street and U Street looking up New Hampshire Avenue.

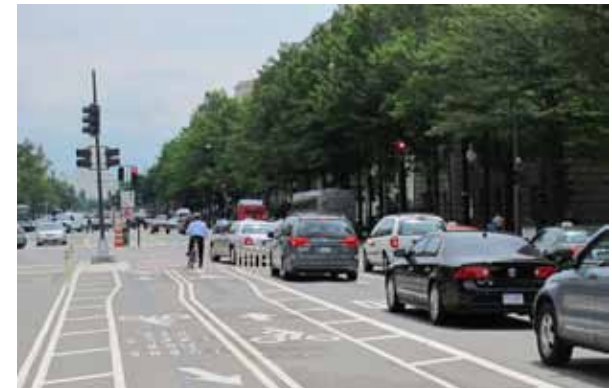
Pennsylvania Avenue at 11th Street.

Bicycle lanes were installed in the center median of the Pennsylvania Avenue NW roadway (with no grade or barrier separation) between 3rd Street and 15th Street. Pennsylvania Avenue is a high-volume street that connects the White House to the Capitol Building, and it is also an important bicycle corridor. The eight-lane street has high vehicle speeds and volumes, including many buses and trucks and a lack of dedicated bike facilities, which created uncomfortable conditions for bicycling.

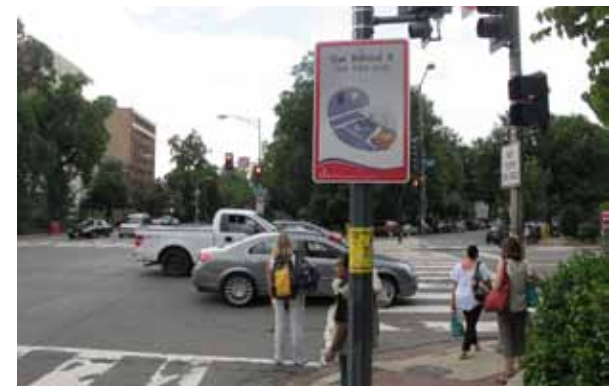
16th Street and U Street bike box sign.

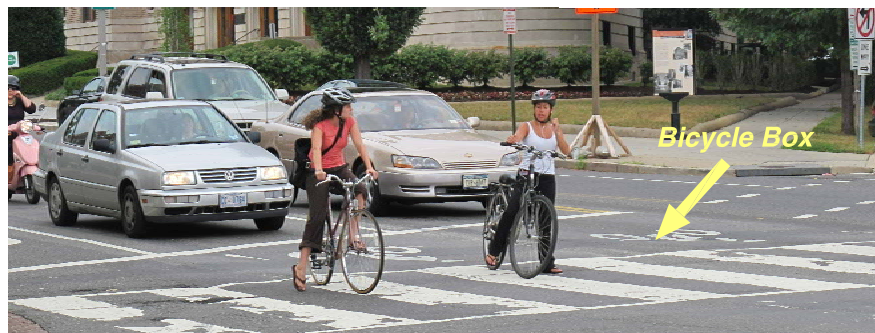
Figure 2. Southbound cyclists on 16th Street.

- *Bicycle boxes* were installed on the northbound and southbound approaches on 16th Street (as shown Figure 2). The bicycle boxes are located between the crosswalks and the vehicular stop bars. They provide an area for bicyclists crossing 16th Street on the green bicycle phase to queue in front of motor vehicles before crossing U Street. The bicycle boxes are meant to make bicyclists more visible to drivers, thereby reducing conflicts and crashes.

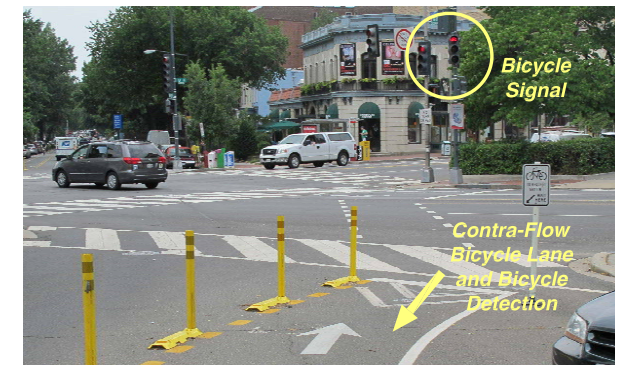
Figure 3. Southbound approach on New Hampshire Avenue.

- *Bicycle signals* were installed on the northwest and southeast corners of the intersection (as shown in Figure 3). Bicyclists receive their own signal phase to allow bicyclists to travel from the New Hampshire Avenue contra-flow bicycle lanes to the 16th Street bicycle boxes without having to cross the intersection using the pedestrian crosswalks. No motor vehicle movements run concurrently with the bicycle signal phase.

- *Contra-flow bicycle lanes* are provided on New Hampshire Avenue for bicyclists traveling in the opposite direction as the vehicular traffic (as shown in Figure 3). The contra-flow bicycle lanes legalize the movement of cyclists in the opposite direction of motor vehicle traffic on New Hampshire Avenue and notify drivers of the likely presence of cyclists.

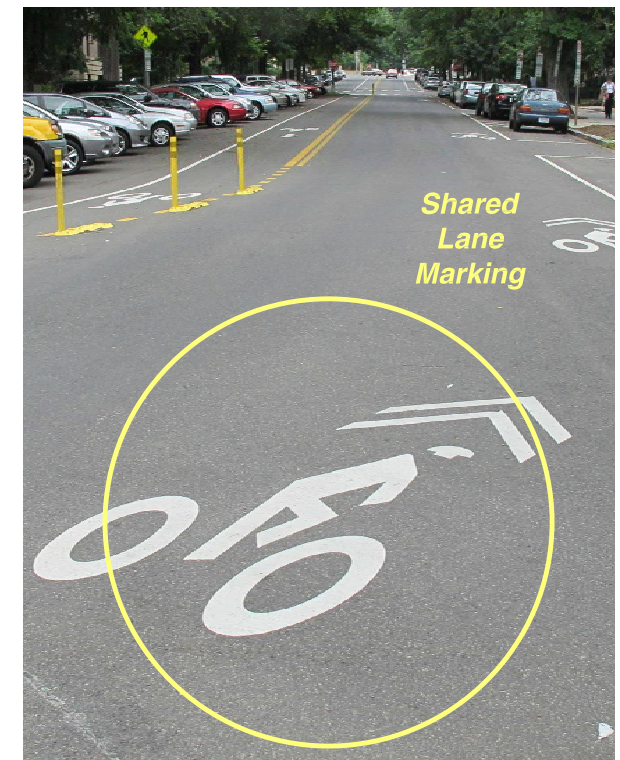
Figure 4. Looking north on New Hampshire Avenue.

- *Shared lane markings* have been added to New Hampshire Avenue for cyclists traveling in the same direction as vehicular traffic (as shown Figure 4). The shared lane markings help improve cyclist positioning in the roadway and inform drivers of the potential presence of bicycles.

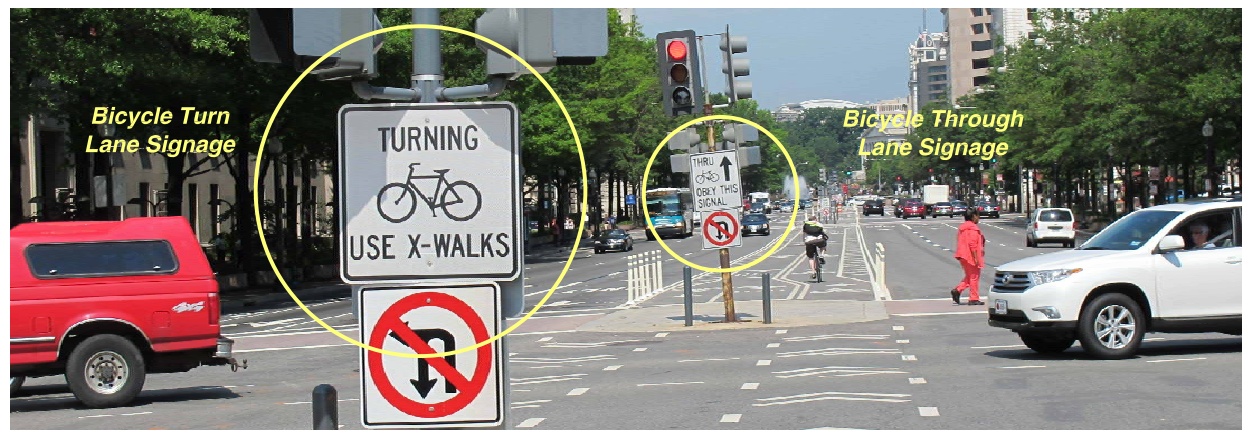
Figure 6. Westbound signals and signage at the 9th Street Intersection.

left-turns. The new signal timing separates the left-turn phase from the adjacent through phase (e.g., the westbound through movement receives a red signal indication whenever the westbound left movement receives a green indication). This is because the same signal indication controls both through bicyclists and through motorists (i.e., the same signal head controls both through bicyclists and through motorists), and a concurrent movement would place through bicyclists in conflict with left-turning motor vehicles.

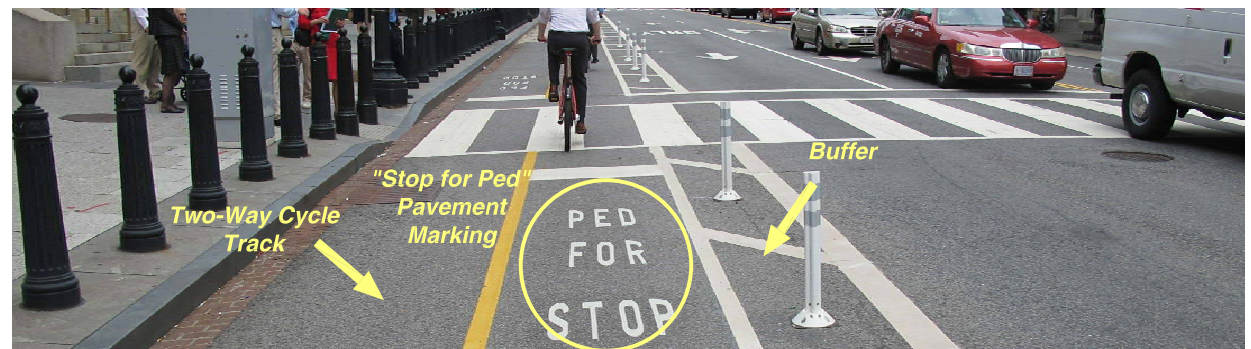
Figure 8. Two-way cycle track near F Street intersection.

- *Cycle tracks* were constructed on the west side of the roadway with a buffer (as shown in Figure 8). The cycle track was designed to provide added safety and comfort for bicyclists traveling along 15th Street by separating all cyclists from vehicular traffic.
- *Shared lane markings* were added through intersections to indicate the likely presence of bicyclists to motorists and indicate the need for turning motorists to yield to cyclists (as shown in Figure 9).
- *STOP FOR PEDESTRIAN* markings were added at mid-block crosswalks and T-intersections to indicate to bicyclists to yield to crossing pedestrians (as shown in Figure 8).

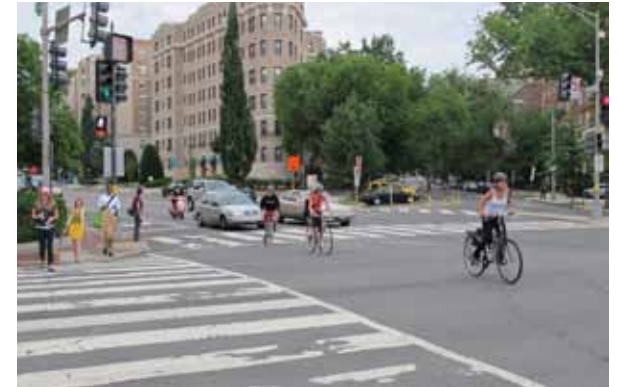
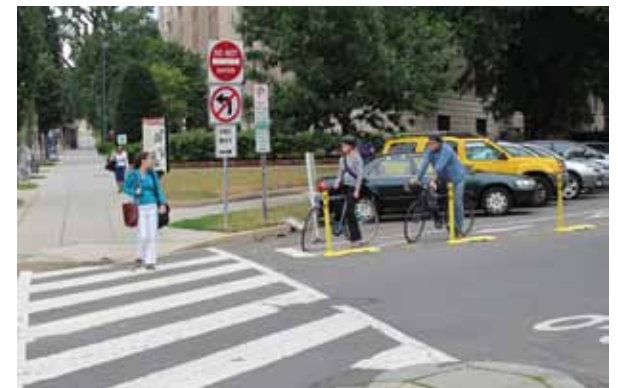
Top: Cyclists get a head start at 16th Street and U Street southbound. **Bottom:** Cyclists wait on detector loops at 16th Street and U Street southbound.

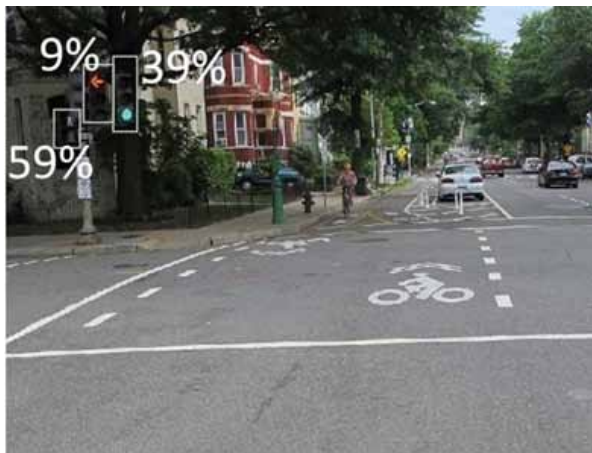
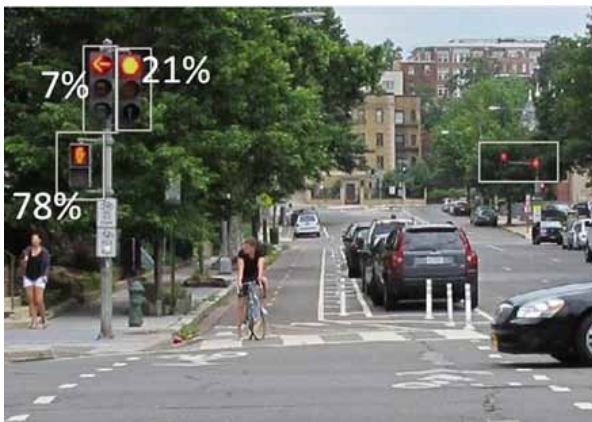
Figure 14. 15th Street cyclist survey: signal selection. **Top:** Intersection of 15th and S Street. **Bottom:** Intersection of 15th Street and U Street.

- **There are potential issues with the existing design, which uses the pedestrian signal to control cyclist movements.** According to the survey responses, many cyclists (approximately 20–30 percent) watch the through motor vehicle green, which could result in conflicts with left-turning vehicles during the protected left-turn phase (Figure 14). Issues with comprehension may contribute to the high rate of violations of the pedestrian signal by cyclists, especially by southbound cyclists.

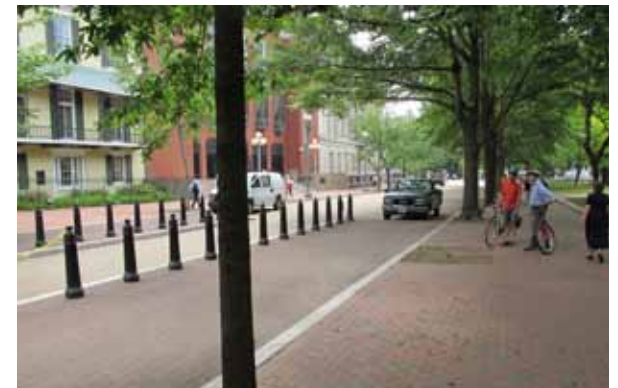
The Whitehouse Plaza area along the 15th Street cycle track.

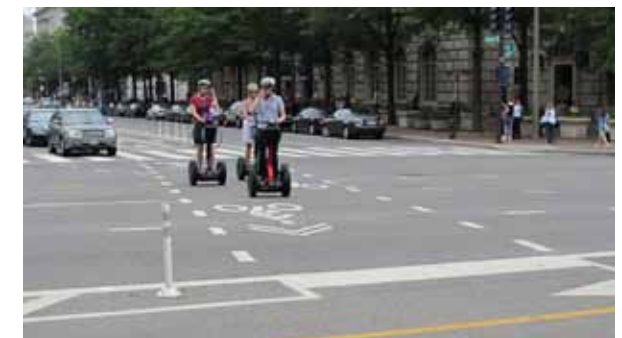
Segways use the bike lane at Pennsylvania Avenue and 15th Street.

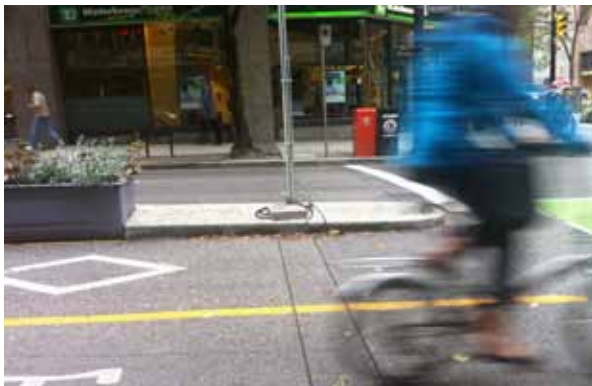
Automated bicycle counters can provide continuous information on facility use.

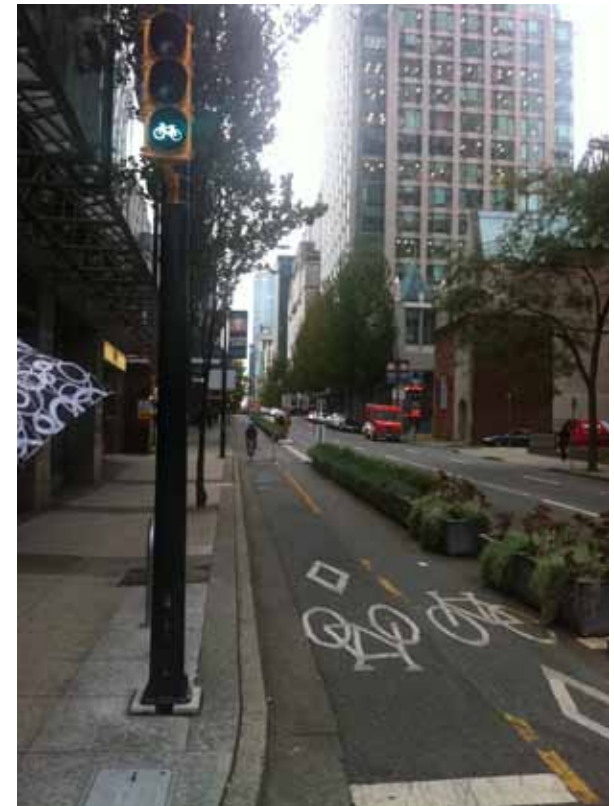
New signal pole and signal head installed to control contra-flow movement on a two-way cycle track along a one-way street.

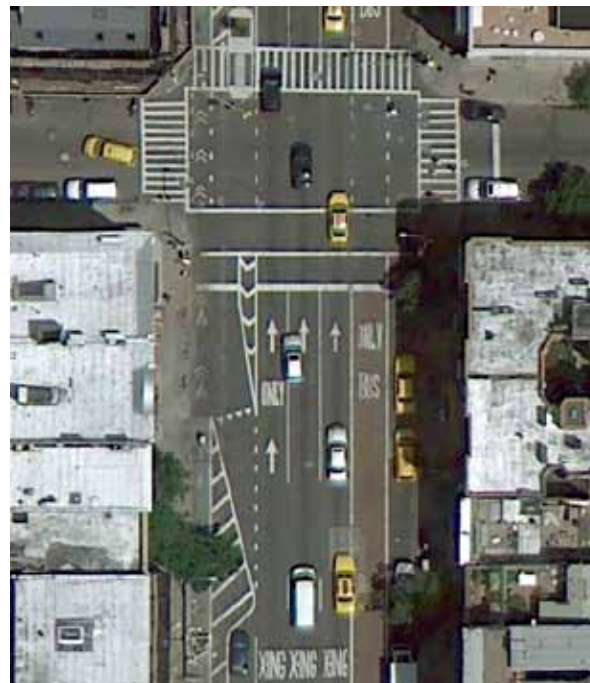
Mixing zones provide an alternative method of addressing bicycle-motorist conflicts at intersections along cycle tracks.

Because cyclist surveys taken as part of the DDOT facility evaluation indicate that cyclists strongly prefer separation from vehicles, mixing zones are likely to decrease cyclist comfort when used at intersections with high turning volumes. As a result, the appropriateness of mixing zones depends strongly on turning volumes; at intersections with high volumes of turning vehicles, separating bicycle movements from turning vehicles through protected bicycle signal phases is likely to be most appropriate.

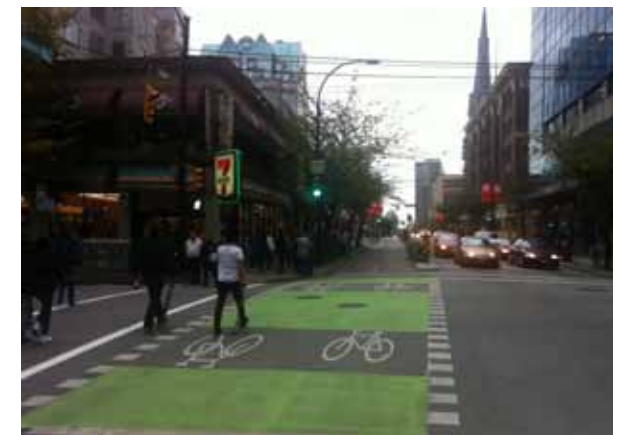
Colored pavement at intersections make bicycle facilities more visible to turning motorists.

In either case, the change in pavement material is the important feature of the green paint, indicating to cyclists and vehicles that a change is taking place (i.e., entering or leaving a conflict zone).

While this research did not examine colored pavement, we nonetheless recommend the use of colored pavement specifically for conflict areas rather than for entire bicycle facilities. There are several reasons for this recommendation. Use of colored pavement only in conflict areas:

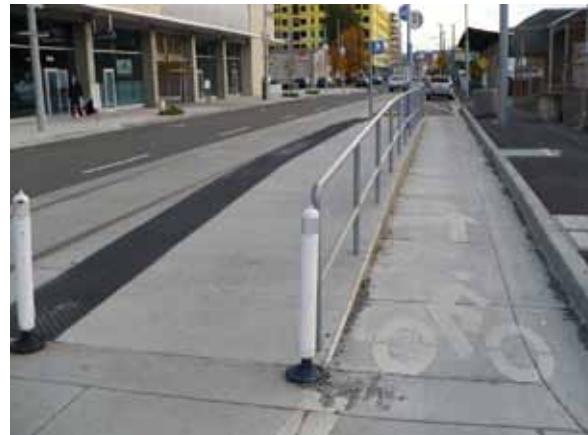
Transit stop designs to accommodate bikes at streetcar stops could be adapted for use at bus stops along cycle tracks.

akin to that of bicycle facilities along streetcar tracks where the streetcar stop uses a curb extension and the bicycle facility travels behind the transit stop adjacent to the sidewalk. This treatment is likely to add considerable expense to the construction cycle tracks along transit routes, but may be necessary to maintain compliance with the Americans with Disabilities Act for transit service.
