A Review of Literature:

Intersection Treatments to Improve Bicycle Access and Safety

Lynn Weigand, Ph.D.

June 2008

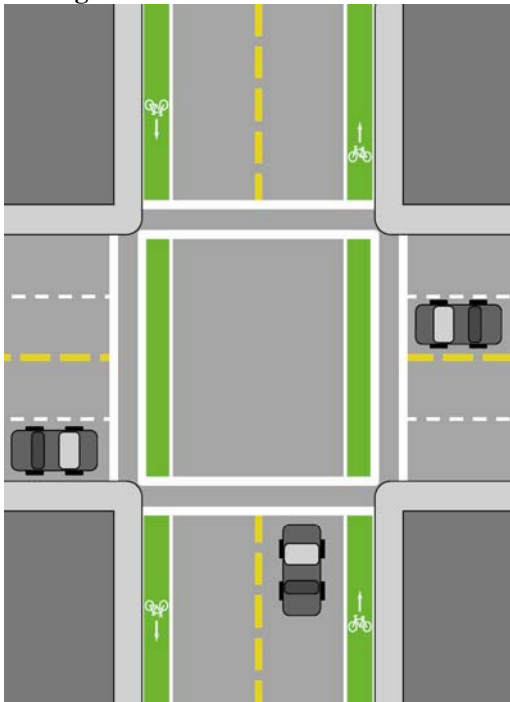
Figure 1: Colored Bicycle Lane Marking Through Intersection

Colored bicycle crossings provide a lane marking in a highly visible color for cyclists through an intersection to warn drivers of potential conflicts and provide cyclists with a designated route through the intersection (see

Figure 1). They are one of the few treatments that focus on the intersection rather than the approach. A study of this treatment at 65 signalized intersections in Copenhagen found that marking only bicycle lane through the intersection in a single direction reduced the number of crashes by ten percent. They found that marking two or more bike lanes across the intersection in any direction increased the number of crashes (Jensen 2007). The authors speculated that two or more marked cycle crossings may have been confusing to motorists and perhaps were disregarded, while one lane marking was clear and legible. However, they also cautioned that the safety benefits of the colored crossing through the intersection also depended on the other factors, such as intersection size, traffic volume, and number of “legs” entering the intersection.

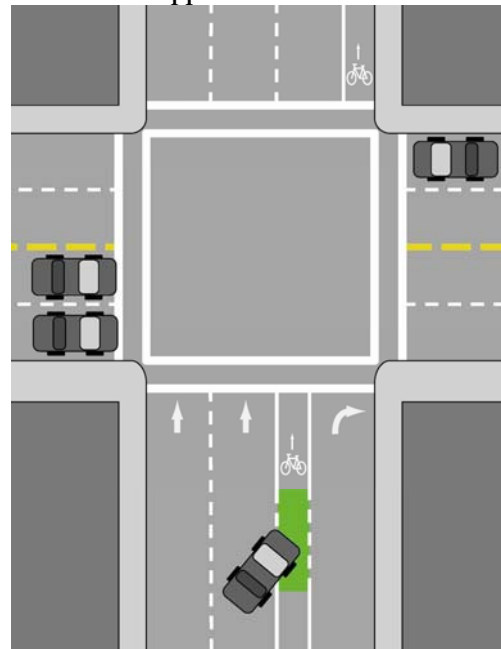
Figure 2: Colored Bicycle Lane Marking at Intersection Approach

Vehicle right-turning movements are a common source of conflict between vehicles and bicycles at intersections where bike lanes are striped on the right side of roadway approaching the intersection. A colored bicycle crossing delineates the path where the bike lane crosses a motor vehicle lane to position the cyclist on the left side of a vehicle right-turn lane to avoid the potential for “right-hook” conflicts during the green phase of the signal. These crossings are typically accompanied by a signage indicating the designated path for both vehicles and bicycles.

European and Canadian cities have used the colored markings and found that they help improve bicyclist safety and reduce conflicts with vehicles (City of Portland Office of Transportation 1999). However, until recently, it was untested in American cities. Portland, Oregon was the first to install and evaluate colored bicycle crossings. Hunter (2000) conducted a pre- and post-evaluation of the safety effects of colored bicycle crossings at ten intersections in Portland,

Oregon. They concluded that the crossings enhanced cyclist safety by making both motorists and bicyclists aware of the conflict area and found a reduction in conflicts after the lanes were installed. Specifically, they found that significantly more motorists yielded to bicyclists after the pavement markings were installed. However, they also found that cyclists were less likely to use hand signals or turn their head before crossing the lane, potentially indicating a false sense of security provided by the lane markings.

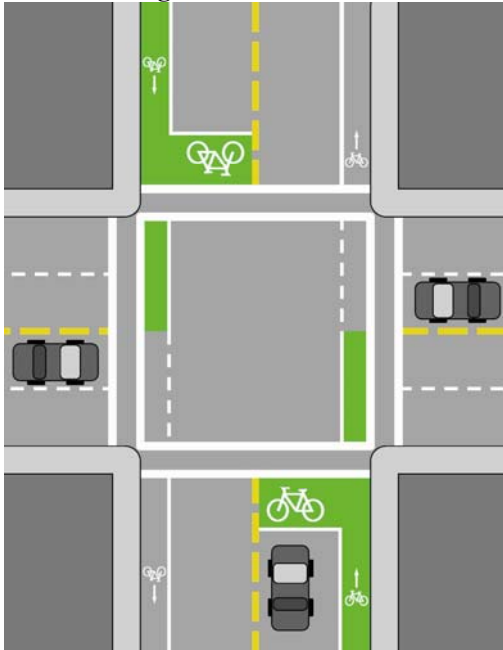
Figure 3: Bike Box Design Treatment in Portland, Oregon

The bike box, also known as the advanced stop line, is a treatment that allows bicyclists to move in front of vehicles when stopped at a signalized intersection. It consists of a marked or colored waiting area that spans the width of the vehicle travel lane (see Figure 3). The intent is to reduce the risk of conflict between cyclists and drivers, primarily when cyclists are attempting to proceed straight through the intersection and drivers are attempting to turn right across the cyclist’s path, also known as a “right-hook” conflict. Advanced stop lines have been adopted primarily in Europe with few applications in the U.S.

Three studies of advanced stop lines have been conducted in the UK (Wheeler 1995; Wall, Davies et al. 2003; Allen, Bygrave et al. 2005). Allen et al. examined 12 sites receiving the ASL treatment and two control sites in the greater London area, using video to record bicyclist and driver behaviors and level of conflict at the sites. This study did not record behaviors before the design treatments were installed. Wheeler (1995) conducted an earlier study of four advanced stop lines in Bristol, Cambridge and Manchester. This study also used video to record driver and cyclist behavior at the sites, and included a pre-installation study at one site. Wall et al. (2003) used before and after video surveillance and cyclist questionnaires at four sites in Surrey in the U.K. The papers do not indicate if signage was present at the sites to indicate proper usage of the design treatment.

All three studies found that cyclists were able to access the bike box and position themselves in front of the vehicles when waiting for the signal. Allen et al. and Wall et al. concluded that this position reduced the potential for conflicts with vehicle turning movements on green signal. Allen et al.

All three studies found problems with motor vehicle encroachment. Allen et al. found that 36% of the cyclists across all the study sites experienced some level of vehicle encroachment into the ASL. All of the studies concluded that drivers need to be encouraged to comply with the bike box markings through signs, education and enforcement, and important to maintain the visibility of the markings. Wall et al. (2003) found no evidence that the drivers were delayed by cyclists queuing in front of the vehicles, and that proportion of vehicles going straight or turning remained similar. Other impacts of the Wall et al. study were difficult to assess because design changes, such as vehicle lane removal and bicycle lane additions, were made at the same time the advanced stop lines were installed.

Studies of bike boxes in the U.S. are limited. An evaluation of a bike box installation at a Eugene, Oregon intersection by Hunter (2000) found that the rate of bicycle-vehicle conflicts changed little before and after the bike box was installed, and no conflicts took place when the bike box was used as intended. The study did find problems with motor vehicle encroachment into the box, leading the authors to recommend bold demarcation and education for both drivers and cyclists with installation of this treatment. However, the treatment design in this study was unique because the bike lane shifted from one side of the street to the other through the intersection, limiting the ability to generalize from these results.
